# The Wissahickon Mills Foundation (WMF) A 501(c)(3) Public Charity

## Report to Foundation Subscribers & Friends and the Robeson Rolling Mill Inspection Report

## 2023 Structural Inspection and 2024-2031 Goals

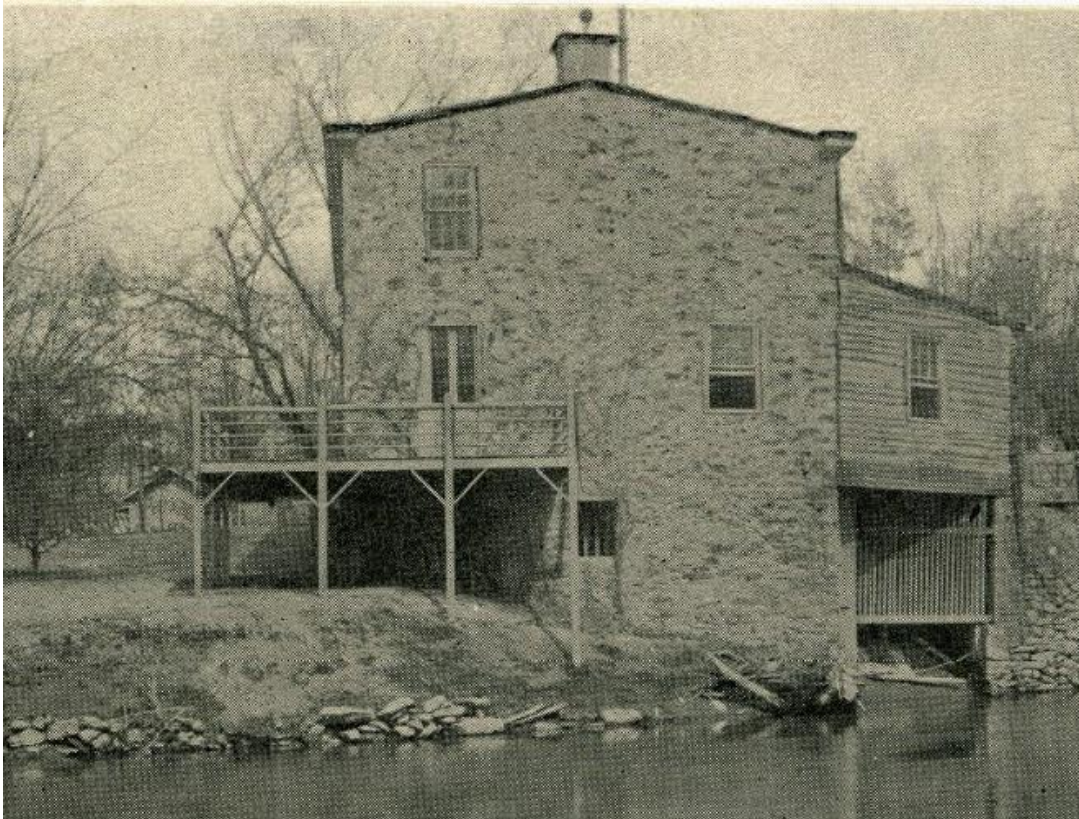
**1906 Porch added with door, pre-Creek Wall**

Views of the Retaining Wall. Unseen: the bottom 4 feet have suffered notable scouring and is missing considerable amounts of mortar.

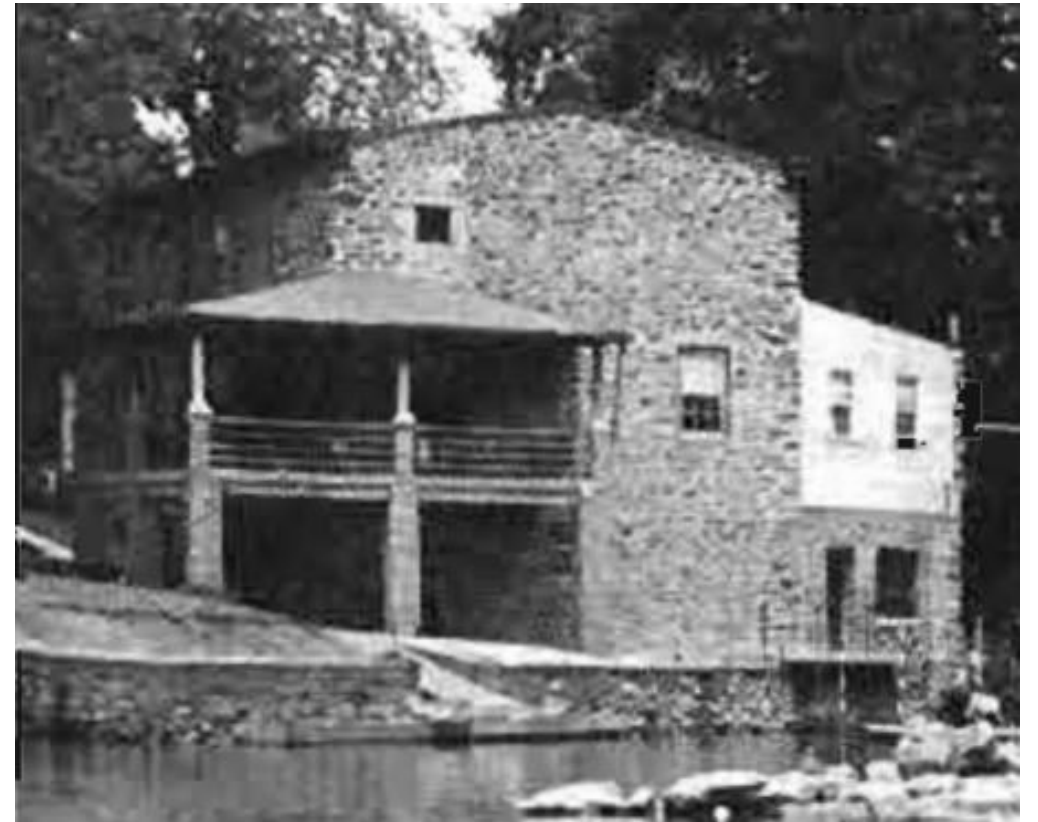
**1975 - Wall added c. 1929-1934 & Wheel Pit/Bilge Wall added tbd**

*Hurricane Ida damaged part of the retaining wall but, more importantly, it revealed that the scouring of mortar in the lowest section was more extensive than realized before the hurricane.*

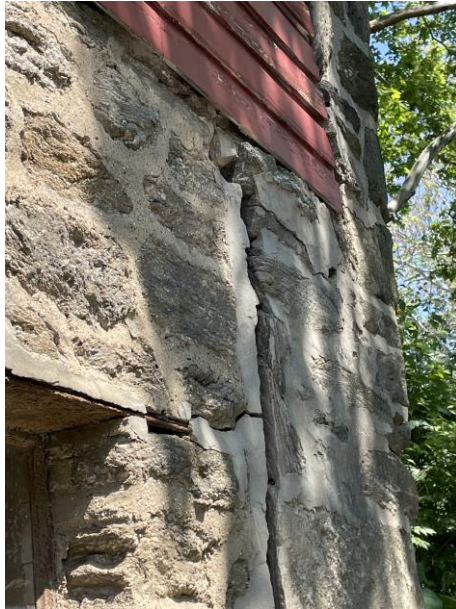
**Bilge – Wheel Pit** below the Kitchen:  
Repair the east wall facing the Creek (High), Upgrade Columns & dig new Footings - the six columns support the Kitchen Floor (High), + Plus notable masonry work (Med-Low priorities).

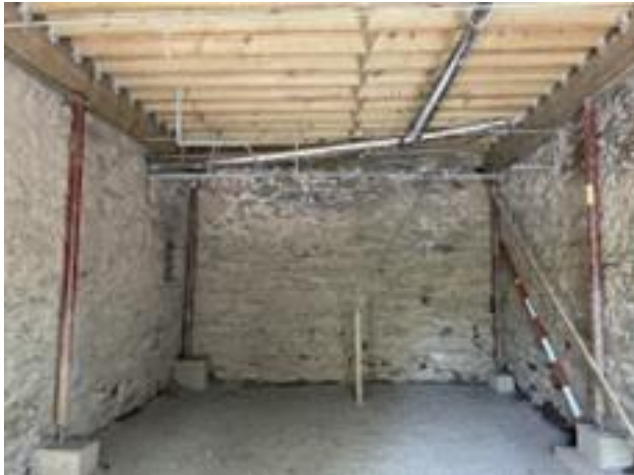
**Porch:**  
Various brick, masonry and concrete repairs to the Porch and its floor (these are rated as Medium Priority(3-5 years). Several of the smaller repairs are rated High Priority (see details last pages in the Appendix).

BUILDING COMPONENT	MATERIAL	OBSERVATIONS	RECOMMENDATIONS	QUANTIT Y	UNIT	PRIORITY	ID TOTAL COST
Porch Structure	Concrete and steel	Cracks throughout. Spalling throughout. Steel W beams (Beams are 1' deep and 6.5" wide) are embedded in concrete causing spalling and jacking. Caulk has been used in cracks. Prior repairs have removed concrete from steel beams and coated with an anti-corrosion product.	The prior repair at the steel beams should be replicated where the steel is still embedded. Remove the concrete below, and coat the beam with an anti-corrosion product. Total 8 beams: 2x 10 LF, 2 x 11 LF, 2 x 125", interior 9 LF, interior 10'-8". Beams are 1' deep and 6.5" wide.	82	LF	Med	\$ 14,436.33

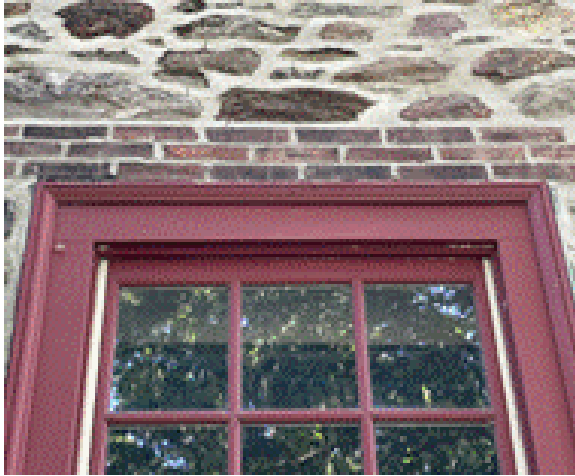
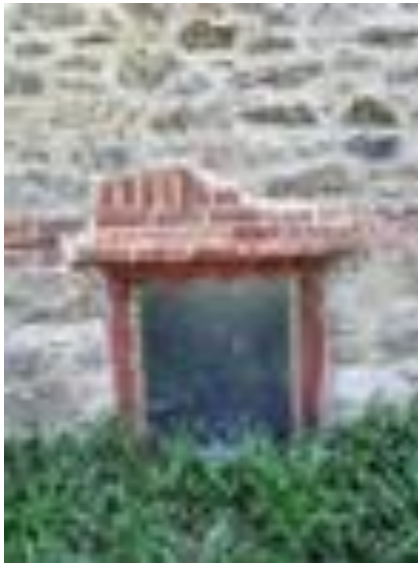
**Windows:**  
Replace the sagging Brick above seven Windows with true headers/steel lintels, and masonry work above these windows and, in one case, below the window. All ranked as Medium Priority.

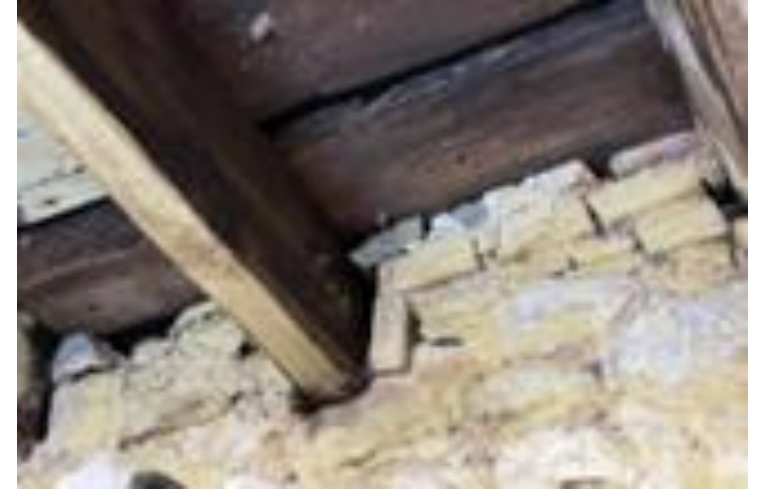
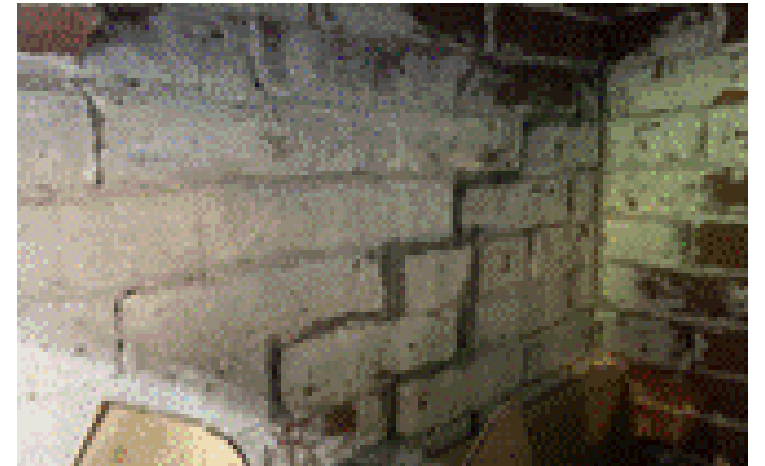
**Walls:** Various Interior Wall masonry Repairs, e.g., Locker Room Wall near Roof. All rated as Medium except one related to the far-left part of the fireplace that needs Basement support (High priority).

61	Club	<b>Fireplace</b>	Brick	Fireplace mass is sagging at the south end where there is no support in the boat storage area below. Step cracking inside upper recess on south and north walls of fireplace.	Install CMU (concrete masonry units) in the basement below to support mass, assume 6'x2'x2'	24	CF	High	\$100.00	\$ 2,400.00

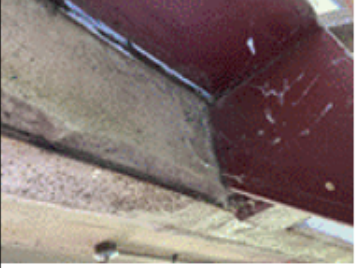
ID	LOCATION	BUILDING COMPONENT	MATERIAL	OBSERVATIONS	RECOMMENDATIONS	QUANTITY	UNIT	PRIORITY	UNIT COST	ID TOTAL COST	Pic. Column Sorts IF Property Pic = "Move and Size with cells"
10A	South	<b>Porch Stair</b>	Wood	Material loss in top tread.	Replace top tread, 45" wide.	3.75	LF	Med	\$150.00	\$ 562.50

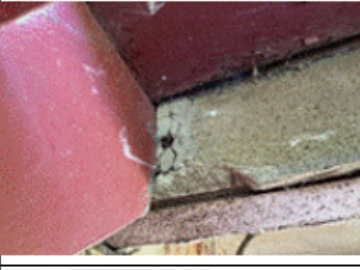
10B	South	<b>Porch Stair</b>	Wood	Stairs slant toward building. Existing stringer at building side is cast into concrete.	Add a center stringer, L=6'-3".	6.25	LF	High	\$275.00	\$ 1,718.75

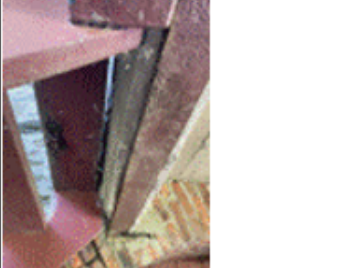
10C	South	<b>Porch Stair</b>	Masonry	Stairs slant toward building. Existing stringer at building side is cast into concrete.	Install a steel clip with long leg and masonry fasteners into sound concrete to reinforce the connection.	1	EA	High	\$150.00	\$ 150.00

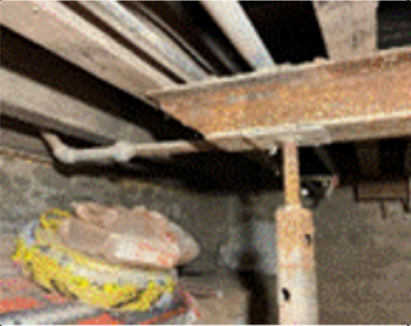
ID	LOCATION	BUILDING COMPONENT	MATERIAL	OBSERVATIONS	RECOMMENDATIONS	QUANTITY	UNIT	PRIORITY	UNIT COST	ID TOTAL COST	Pic. Column Sorts IF Property Pic = "Move and Size with cells"
51C	Steward's Quarters	<b>First Floor Framing</b>	Concrete	(10) steel posts are lally columns. Many of them are situated on a single paver sitting on floor. Pavers at north wall are cracked because floor is uneven and paver is carrying load. Lally columns are approximately 6'-0" tall. Central post west of stairs is leaning and loose and on base.	Replace all pavers with appropriately sized concrete footings. Embed extant posts in concrete footing, 9 posts x 2'x2'x1'.	36	CF	High	\$150.00	\$ 5,400.00

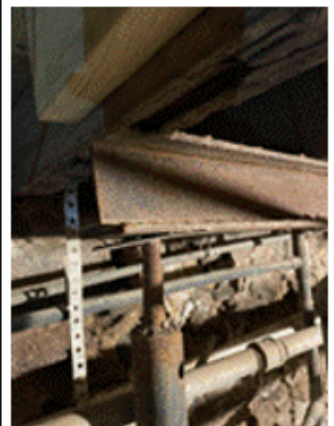
51A	Steward's Quarters	<b>First Floor Framing</b>	Steel	2 3/4" x 8 1/4" floor joists @ 16" O.C. run east/west. Floor joists are supported with supplemental steel framing: (3)W4 steel beams span north-south, slung below floor joists, and have surface corrosion. No fasteners between posts and beams. Steel beams end at stairs. Floor joists starting at #7 from the north wall are sistered with more modern 2x material.	Install fasteners so that posts and beams have stable connection. Drill 2 holes per post connection, 6 EA. (Stairs down to basement are in good condition.)	12	EA	High	\$ 75.00	\$ 900.00
